Montana Department of
ENVIRONMENTAL QUALITY

RE: Corrective Action Management Unit (CAMU) Construction Inspections for July 6, 9, 10, and 16, 2001.

FIELD INVESTIGATION REPORT

SITE: ASARCO East Helena

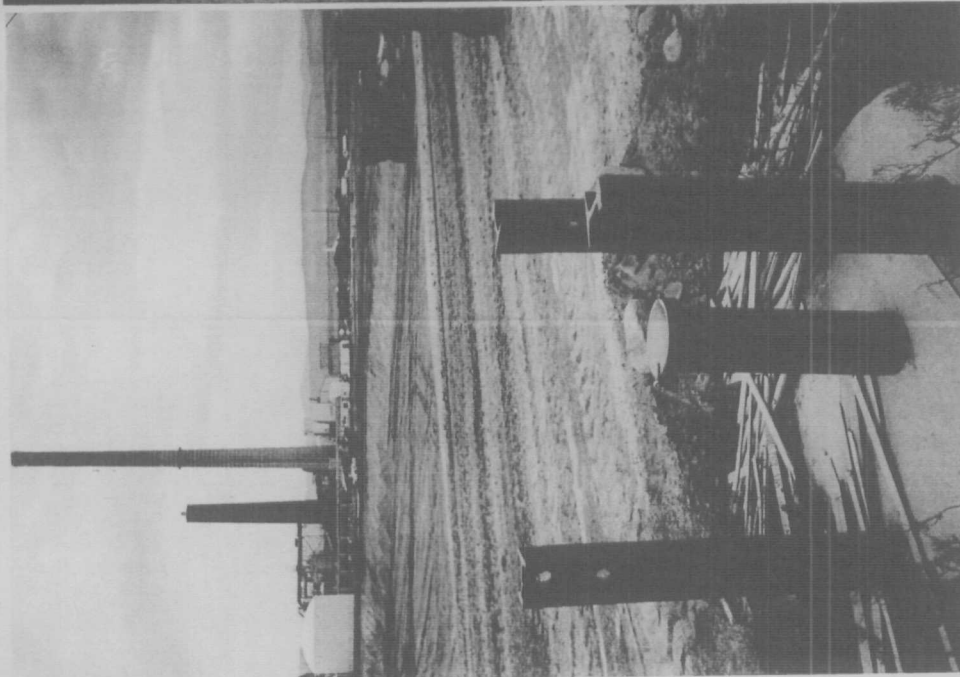
PROJECT/CASE NO: ASARCO E. Helena CAMU
 SUBJECT: Monitoring well MW-1 looking NE
 LOCATION:
 CITY: E. Helena COUNTY: Lewis & Clark
 DATE: 07/09/01 TIME: AM
 WEATHER:(SUN)(HAZE)(**CLOUDY**)(RAIN)(SNOW)
 PHOTOGRAPHER (initials) Adel Johnson *aj*
 WITNESS: Susan Zazzali, EPA
 CAMERA: Vivitar Big View, BV35DB
 FILM TYPE: color ISO: 200
 NEGATIVE LOCATION: Attached to 07/16/01 CEI report
 PROCESSED BY: Montana 1 Hour Photo
 PHOTO# 3

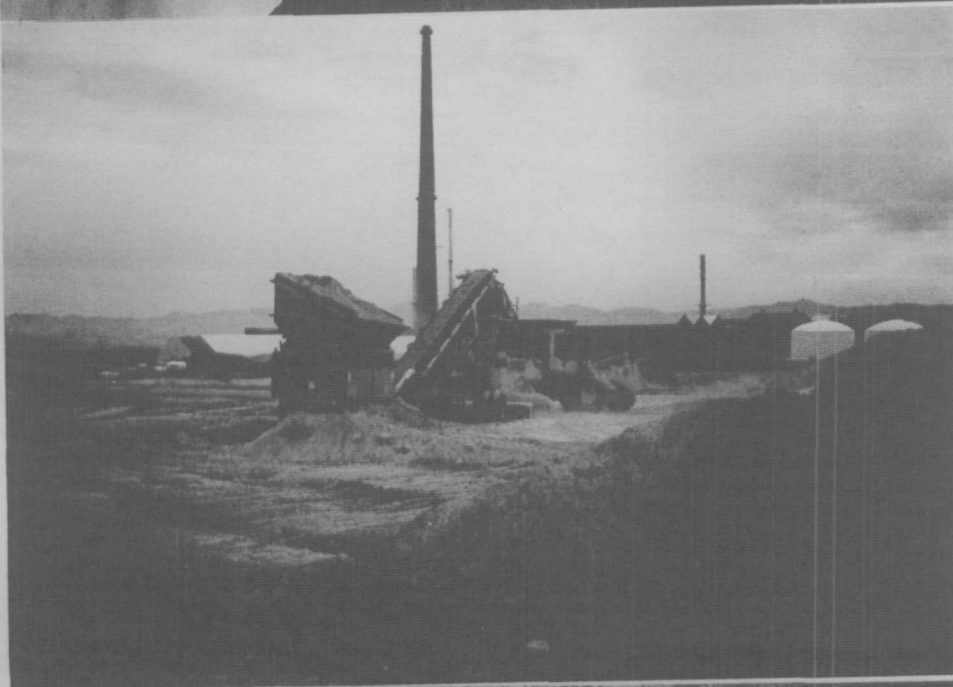
PROJECT/CASE NO: ASARCO E. Helena CAMU
 SUBJECT: Screening plant
 LOCATION: SW edge of construction site looking N
 CITY: E. Helena COUNTY: Lewis & Clark
 DATE: 07/09/01 TIME: AM
 WEATHER: (SUN)(HAZE)(CLOUDY)(RAIN)(SNOW)
 PHOTOGRAPHER (initials) Adel Johnson *aj*
 WITNESS: Susan Zazzali, EPA
 CAMERA: Vivitar Big View, BV35DB
 FILM TYPE: color ISO: 200
 NEGATIVE LOCATION: Attached to 07/16/01 CEI report
 PROCESSED BY: Montana 1 Hour Photo
 PHOTO# 5

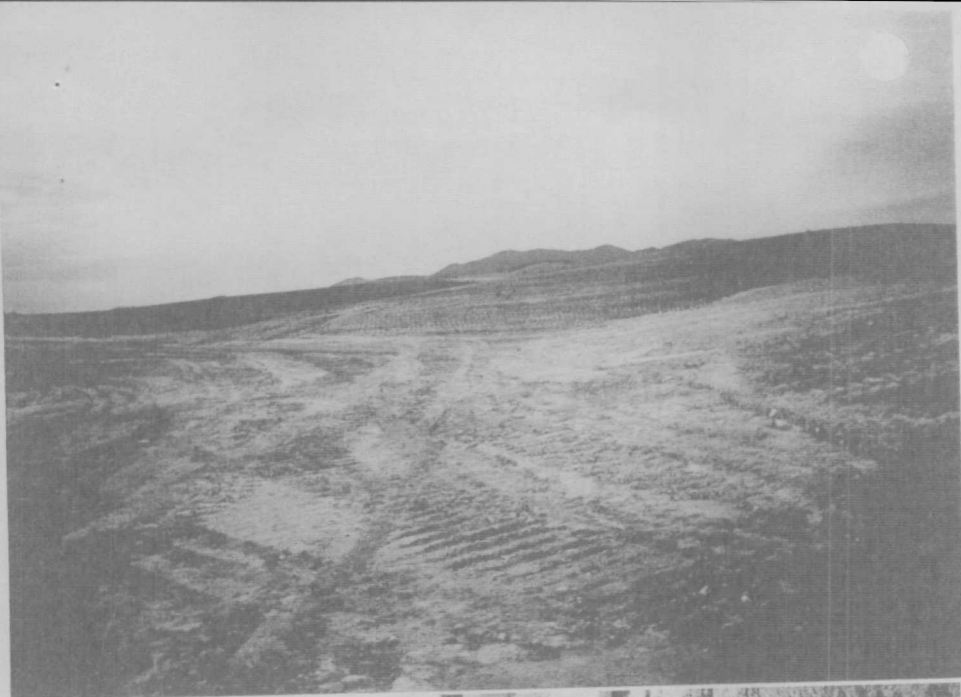
PROJECT/CASE NO: ASARCO E. Helena CAMU
 SUBJECT: Soil stockpiles; dark material pile is topsoil
 LOCATION: SW edge of construction site looking SW
 CITY: E. Helena COUNTY: Lewis & Clark
 DATE: 07/09/01 TIME: AM
 WEATHER:(SUN)(HAZE)(CLOUDY)(RAIN)(SNOW)
 PHOTOGRAPHER (initials) Adel Johnson *AJ*
 WITNESS: Susan Zazzali, EPA
 CAMERA: Vivitar Big View, BV35DB
 FILM TYPE: color ISO: 200
 NEGATIVE LOCATION: Attached to 07/16/01 CEI report
 PROCESSED BY: Montana 1 Hour Photo
 PHOTO# 7

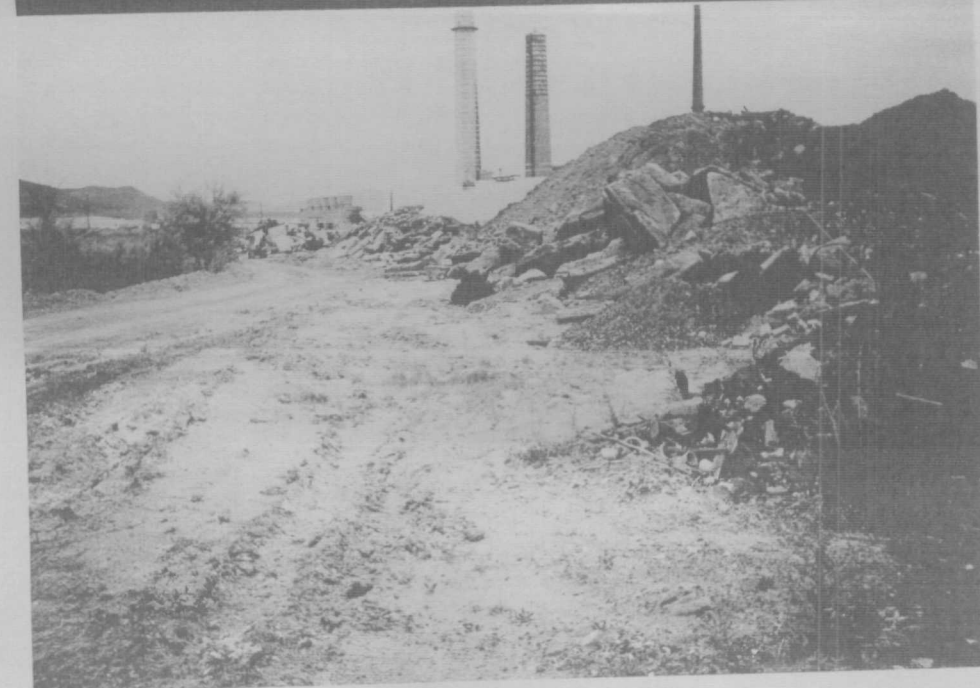
PROJECT/CASE NO: ASARCO E. Helena CAMU
 SUBJECT: Waste pile material; cupels in foreground
 LOCATION: Between Upper and Lower Lake; Upper Lake
 to the left
 CITY: E. Helena COUNTY: Lewis & Clark
 DATE: 07/09/01 TIME: AM
 WEATHER:(SUN)(HAZE)(CLOUDY)(RAIN)(SNOW)
 PHOTOGRAPHER (initials) Adel Johnson *AJ*
 WITNESS: Susan Zazzali, EPA
 CAMERA: Vivitar Big View, BV35DB
 FILM TYPE: color ISO: 200
 NEGATIVE LOCATION: Attached to 07/16/01 CEI report
 PROCESSED BY: Montana 1 Hour Photo
 PHOTO# 9

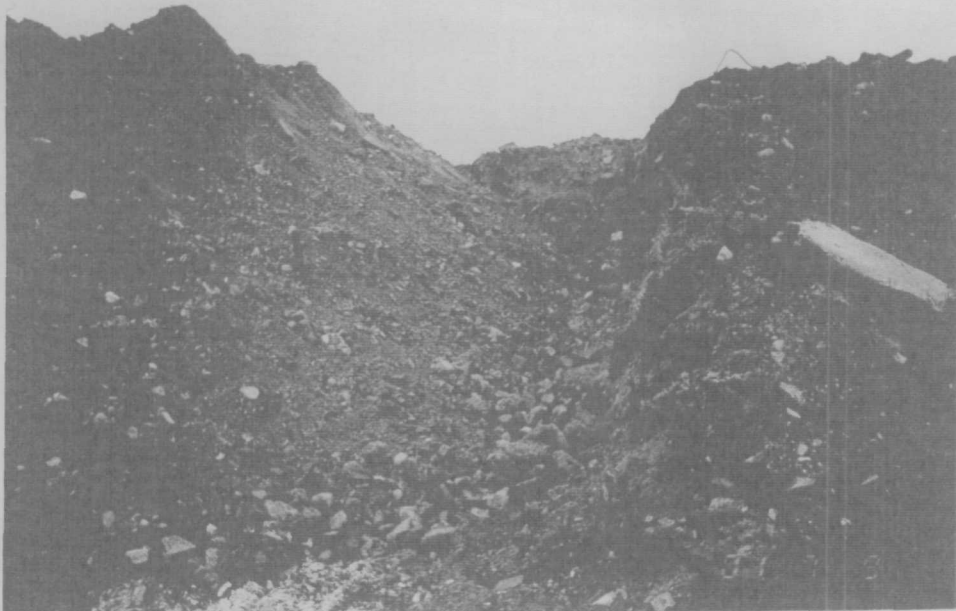
PROJECT/CASE NO: ASARCO E. Helena CAMU
 SUBJECT: Divide between the sorted & non-sorted material
 LOCATION: Between Upper and Lower Lake
 CITY: E. Helena COUNTY: Lewis & Clark
 DATE: 07/09/01 TIME: AM
 WEATHER: (SUN)(HAZE)(**CLOUDY**)(RAIN)(SNOW)
 PHOTOGRAPHER (initials) Adel Johnson *aj*
 WITNESS: Susan Zazzali, EPA
 CAMERA: Vivitar Big View, BV35DB
 FILM TYPE: color ISO: 200
 NEGATIVE LOCATION: Attached to 07/16/01 CEI report
 PROCESSED BY: Montana 1 Hour Photo
 PHOTO# 10

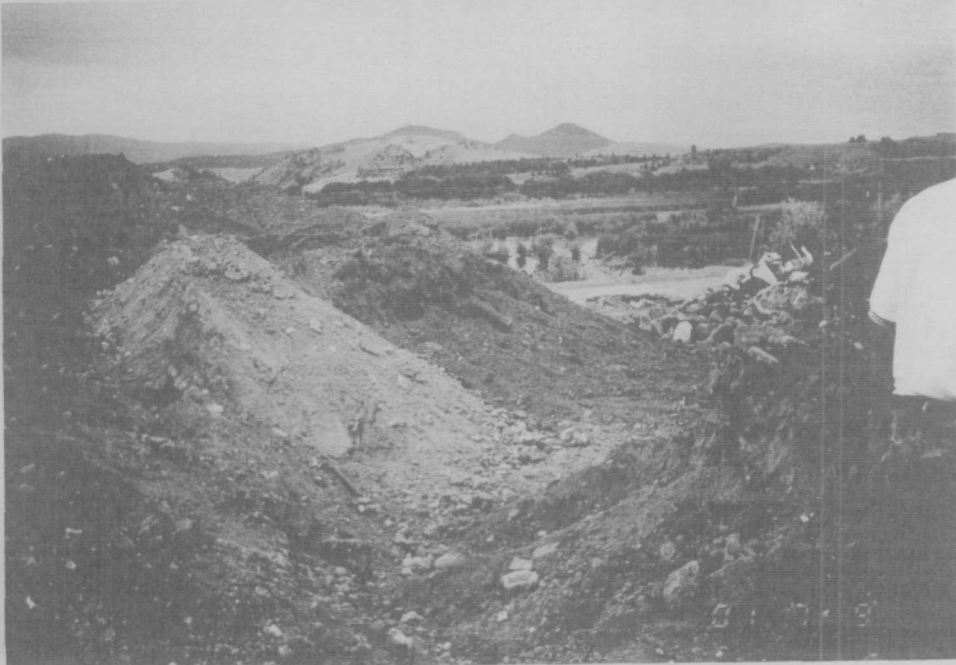
PROJECT/CASE NO: ASARCO E. Helena CAMU
 SUBJECT: Divide between the sorted & non-sorted material
 LOCATION: Between Upper and Lower Lake
 CITY: E. Helena COUNTY: Lewis & Clark
 DATE: 07/09/01 TIME: AM
 WEATHER: (SUN)(HAZE)(**CLOUDY**)(RAIN)(SNOW)
 PHOTOGRAPHER (initials) Adel Johnson *aj*
 WITNESS: Susan Zazzali, EPA
 CAMERA: Vivitar Big View, BV35DB
 FILM TYPE: color ISO: 200
 NEGATIVE LOCATION: Attached to 07/16/01 CEI report
 PROCESSED BY: Montana 1 Hour Photo
 PHOTO# 11

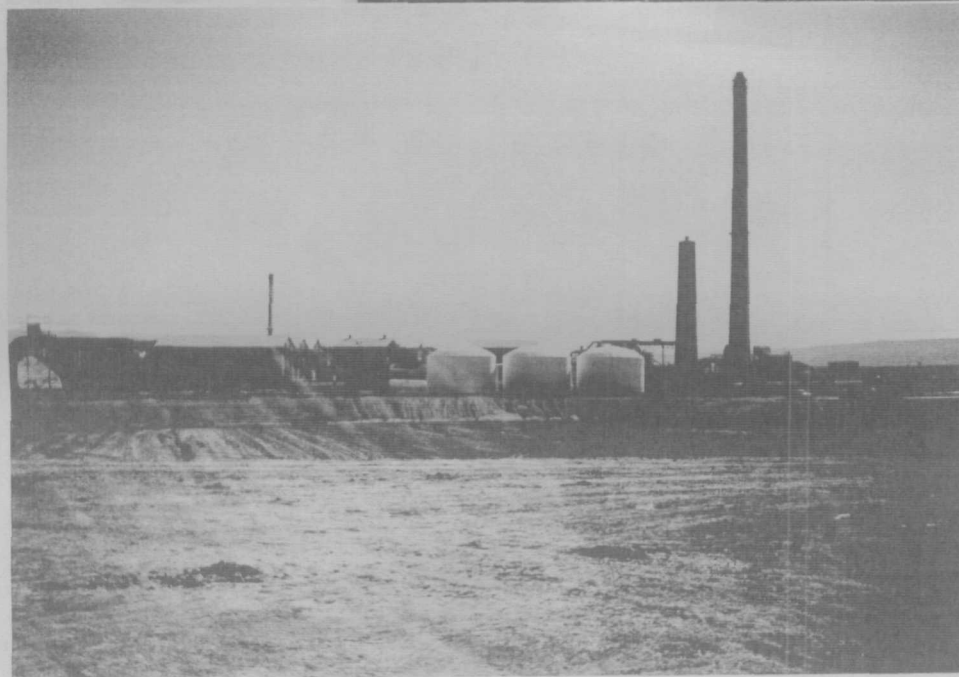
PROJECT/CASE NO: ASARCO E. Helena CAMU
 SUBJECT: Construction of clay liner
 LOCATION: SW edge looking NE
 CITY: E. Helena COUNTY: Lewis & Clark
 DATE: 07/11/01 TIME: AM
 WEATHER:(SUN)(HAZE)(CLOUDY)(RAIN)(SNOW)
 PHOTOGRAPHER (initials) Spence Willett *SW*
 WITNESS: Susan Zazzali, EPA
 CAMERA: Vivitar Big View, BV35DB
 FILM TYPE: color ISO: 200
 NEGATIVE LOCATION: Attached to 07/16/01 CEI report
 PROCESSED BY: Montana 1 Hour Photo
 PHOTO# 3

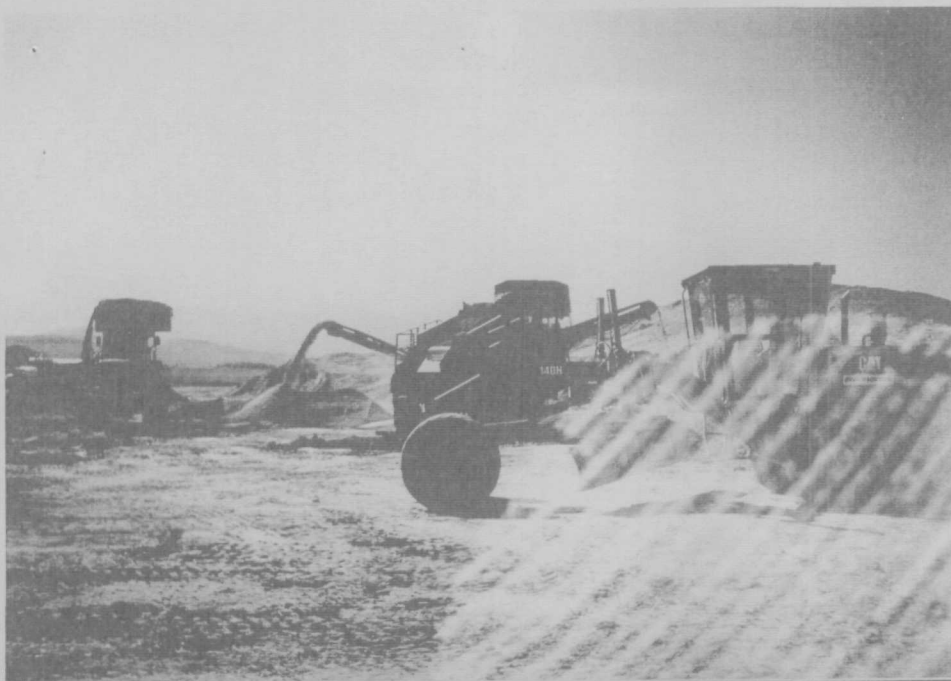
PROJECT/CASE NO: ASARCO E. Helena CAMU
 SUBJECT: New screening plant
 LOCATION: SW of CAMU near soil stockpiles
 CITY: E. Helena COUNTY: Lewis & Clark
 DATE: 07/11/01 TIME: AM
 WEATHER: (SUN)(HAZE)(CLOUDY)(RAIN)(SNOW)
 PHOTOGRAPHER (initials) Spencee Willett S.W.
 WITNESS: Susan Zazzali, EPA
 CAMERA: Vivitar Big View, BV35DB
 FILM TYPE: color ISO: 200
 NEGATIVE LOCATION: Attached to 07/16/01 CEI report
 PROCESSED BY: Montana 1 Hour Photo
 PHOTO# 4

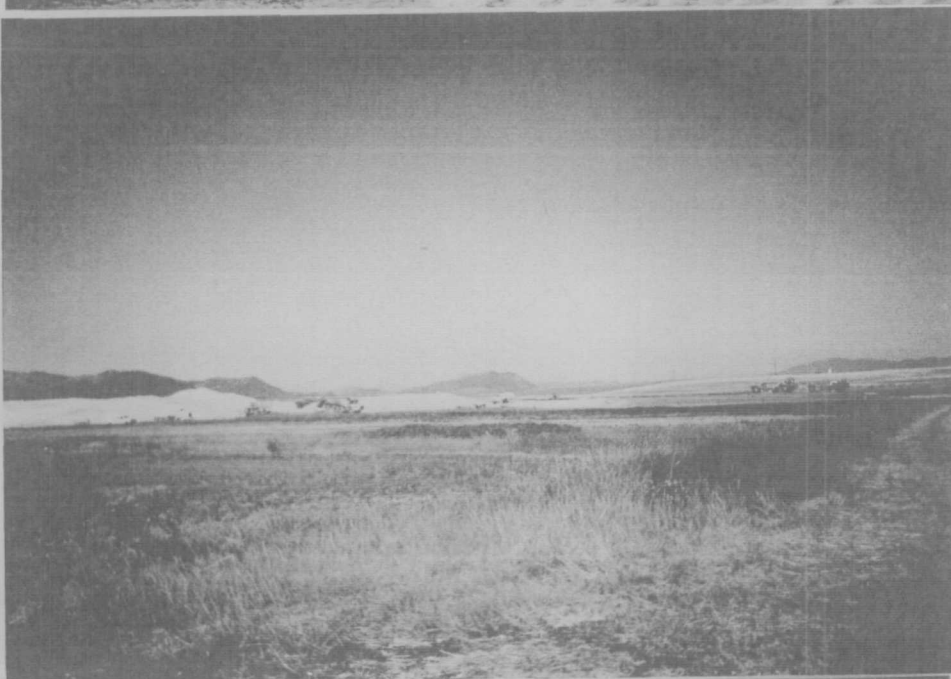
PROJECT/CASE NO: ASARCO E. Helena CAMU
 SUBJECT: CAMU construction site
 LOCATION: View looking NW across construction site
 CITY: E. Helena COUNTY: Lewis & Clark
 DATE: 07/11/01 TIME: AM
 WEATHER: (SUN)(HAZE)(CLOUDY)(RAIN)(SNOW)
 PHOTOGRAPHER (initials) Spencee Willett S.W.
 WITNESS: Susan Zazzali, EPA
 CAMERA: Vivitar Big View, BV35DB
 FILM TYPE: color ISO: 200
 NEGATIVE LOCATION: Attached to 07/16/01 CEI report
 PROCESSED BY: Montana 1 Hour Photo
 PHOTO# 5

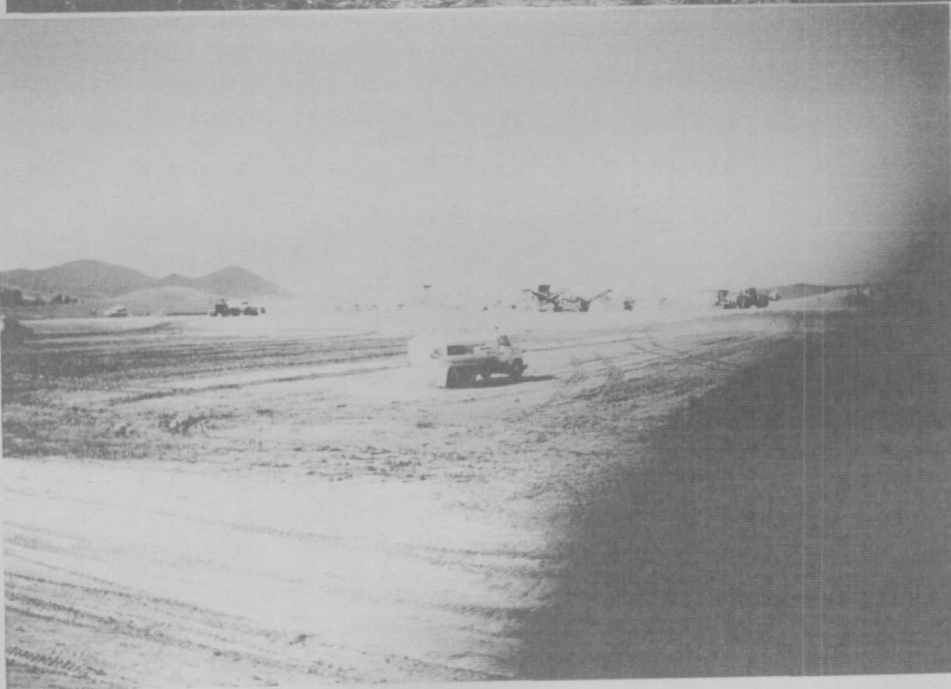
PROJECT/CASE NO: ASARCO E. Helena CAMU
 SUBJECT: Watering the clay liner material
 LOCATION: NE edge looking SW toward material stockpiles
 CITY: E. Helena COUNTY: Lewis & Clark
 DATE: 07/11/01 TIME: AM
 WEATHER: (SUN)(HAZE)(CLOUDY)(RAIN)(SNOW)
 PHOTOGRAPHER (initials) Spencee Willett S.W.
 WITNESS: Susan Zazzali, EPA
 CAMERA: Vivitar Big View, BV35DB
 FILM TYPE: color ISO: 200
 NEGATIVE LOCATION: Attached to 07/16/01 CEI report
 PROCESSED BY: Montana 1 Hour Photo
 PHOTO# 6

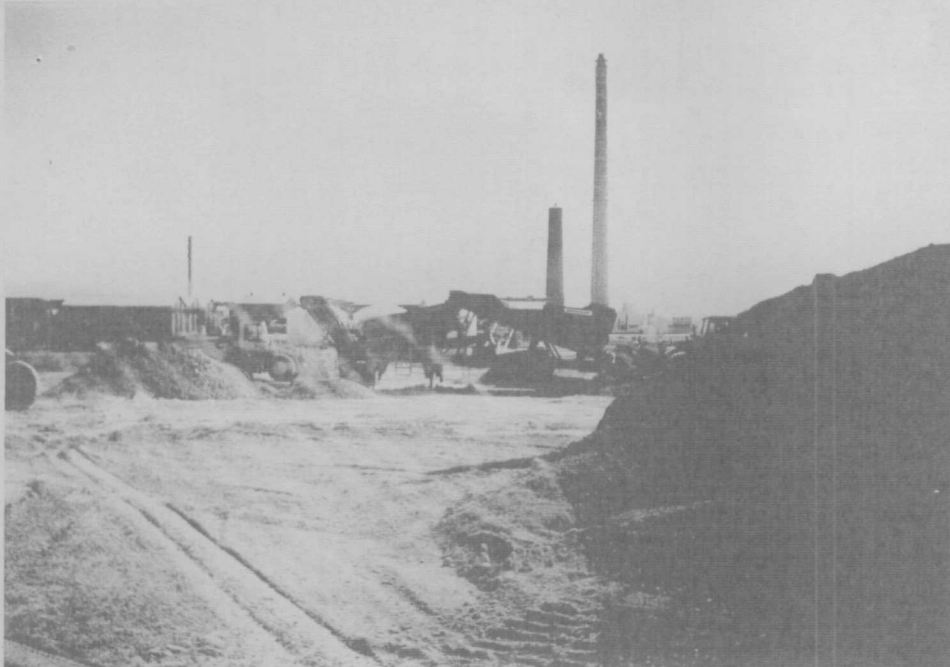
PROJECT/CASE NO: ASARCO E. Helena CAMU
 SUBJECT: Screening operation
 LOCATION: CAMU material stockpiles
 CITY: E. Helena COUNTY: Lewis & Clark
 DATE: 07/11/01 TIME: AM
 WEATHER: (SUN)(HAZE)(CLOUDY)(RAIN)(SNOW)
 PHOTOGRAPHER (initials) Spencee Willett *S.W.*
 WITNESS: Susan Zazzali, EPA
 CAMERA: Vivitar Big View, BV35DB
 FILM TYPE: color ISO: 200
 NEGATIVE LOCATION: Attached to 07/16/01 CEI report
 PROCESSED BY: Montana 1 Hour Photo
 PHOTO# 7

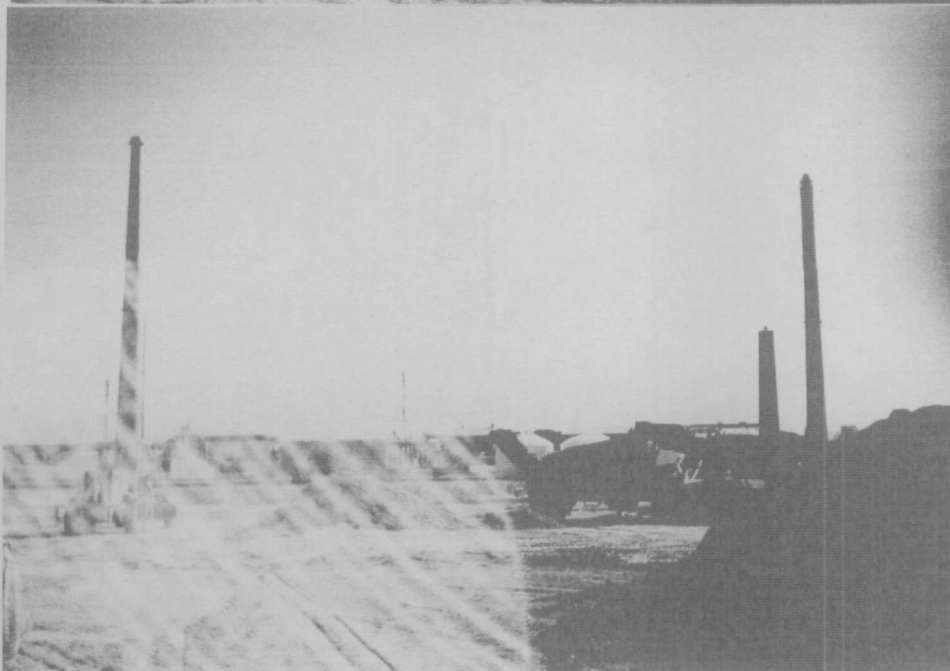
PROJECT/CASE NO: ASARCO E. Helena CAMU
 SUBJECT: Screening operation
 LOCATION: CAMU material stockpiles
 CITY: E. Helena COUNTY: Lewis & Clark
 DATE: 07/11/01 TIME: AM
 WEATHER: (SUN)(HAZE)(CLOUDY)(RAIN)(SNOW)
 PHOTOGRAPHER (initials) Spencee Willett *S.W.*
 WITNESS: Susan Zazzali, EPA
 CAMERA: Vivitar Big View, BV35DB
 FILM TYPE: color ISO: 200
 NEGATIVE LOCATION: Attached to 07/16/01 CEI report
 PROCESSED BY: Montana 1 Hour Photo
 PHOTO# 8

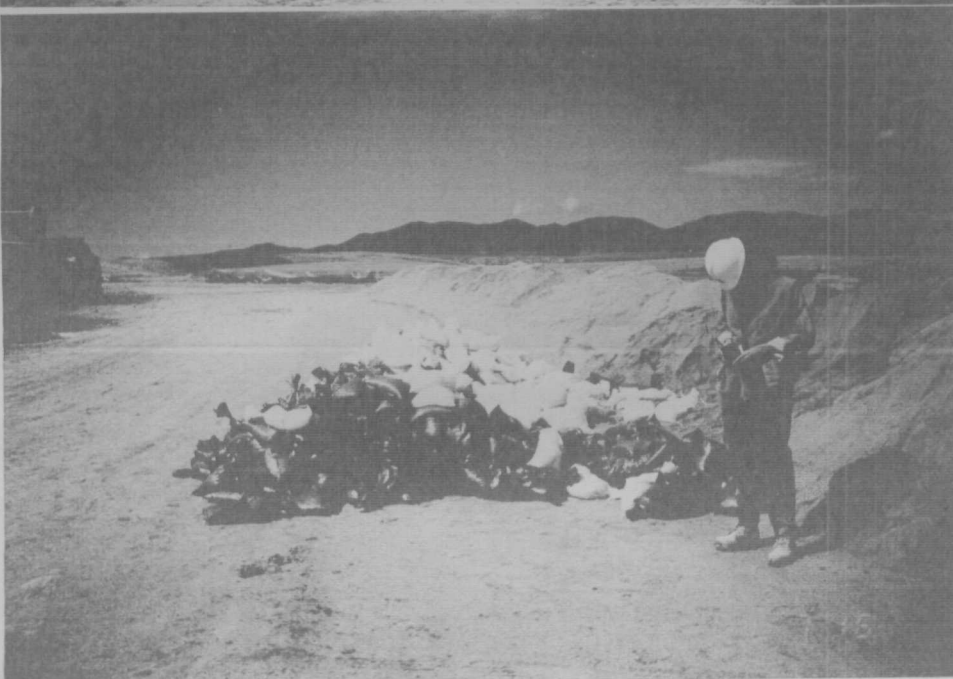
PROJECT/CASE NO: ASARCO E. Helena CAMU
 SUBJECT: Filled sandbags; Susan Zazzali
 LOCATION: NW edge of CAMU
 CITY: E. Helena COUNTY: Lewis & Clark
 DATE: 07/16/01 TIME: AM
 WEATHER: (SUN)(HAZE)(CLOUDY)(RAIN)(SNOW)
 PHOTOGRAPHER (initials) Adel Johnson *AJ*
 WITNESS: Susan Zazzali, EPA
 CAMERA: Vivitar Big View, BV35DB
 FILM TYPE: color ISO: 200
 NEGATIVE LOCATION: Attached to CEI report
 PROCESSED BY: Montana 1 Hour Photo
 PHOTO# 3

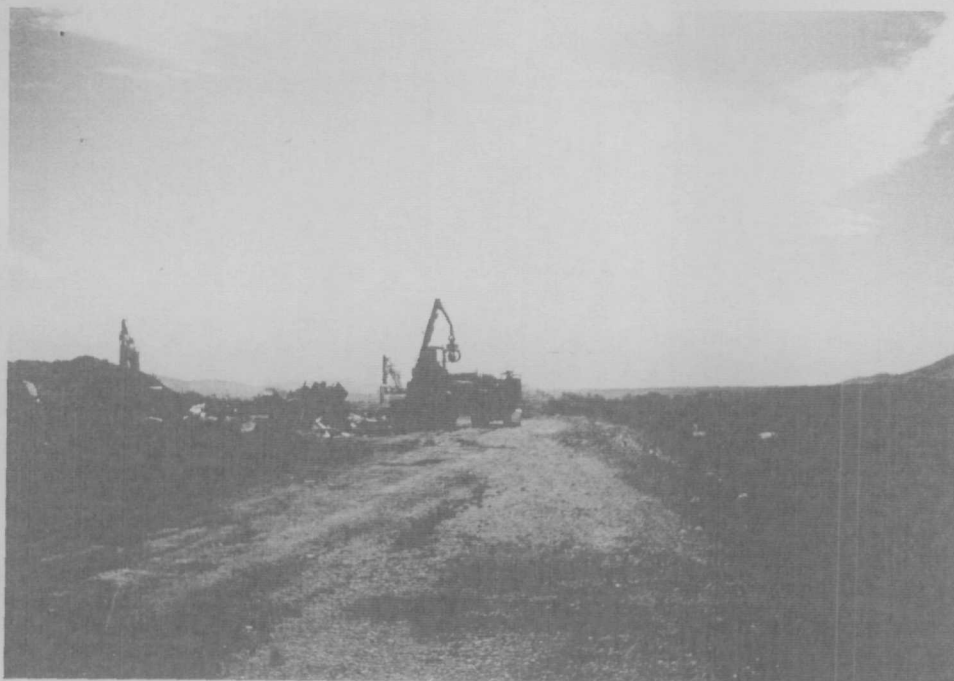
PROJECT/CASE NO: ASARCO E. Helena CAMU
 SUBJECT: Sorting material between Upper and Lower Lake
 LOCATION: S edge of pile looking E; Upper Lake on the right
 CITY: E. Helena COUNTY: Lewis & Clark
 DATE: 07/16/01 TIME: AM
 WEATHER: (SUN)(HAZE)(CLOUDY)(RAIN)(SNOW)
 PHOTOGRAPHER (initials) Adel Johnson *AJ*
 WITNESS: Susan Zazzali, EPA
 CAMERA: Vivitar Big View, BV35DB
 FILM TYPE: color ISO: 200
 NEGATIVE LOCATION: Attached to CEI report
 PROCESSED BY: Montana 1 Hour Photo
 PHOTO# 4

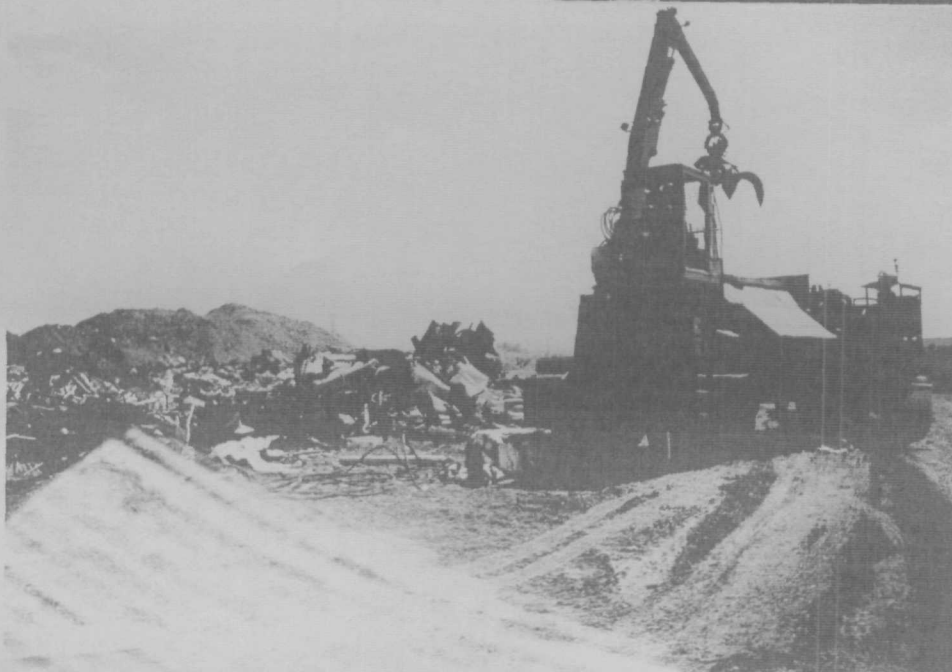
PROJECT/CASE NO: ASARCO E. Helena CAMU
 SUBJECT: Sorting material between Upper and Lower Lake;
 compressed metal block center of photo
 LOCATION: S edge of pile looking E; Upper Lake on the right
 CITY: E. Helena COUNTY: Lewis & Clark
 DATE: 07/16/01 TIME: AM
 WEATHER: (SUN)(HAZE)(CLOUDY)(RAIN)(SNOW)
 PHOTOGRAPHER (initials) Adel Johnson *AJ*
 WITNESS: Susan Zazzali, EPA
 CAMERA: Vivitar Big View, BV35DB
 FILM TYPE: color ISO: 200
 NEGATIVE LOCATION: Attached to CEI report
 PROCESSED BY: Montana 1 Hour Photo
 PHOTO# 6

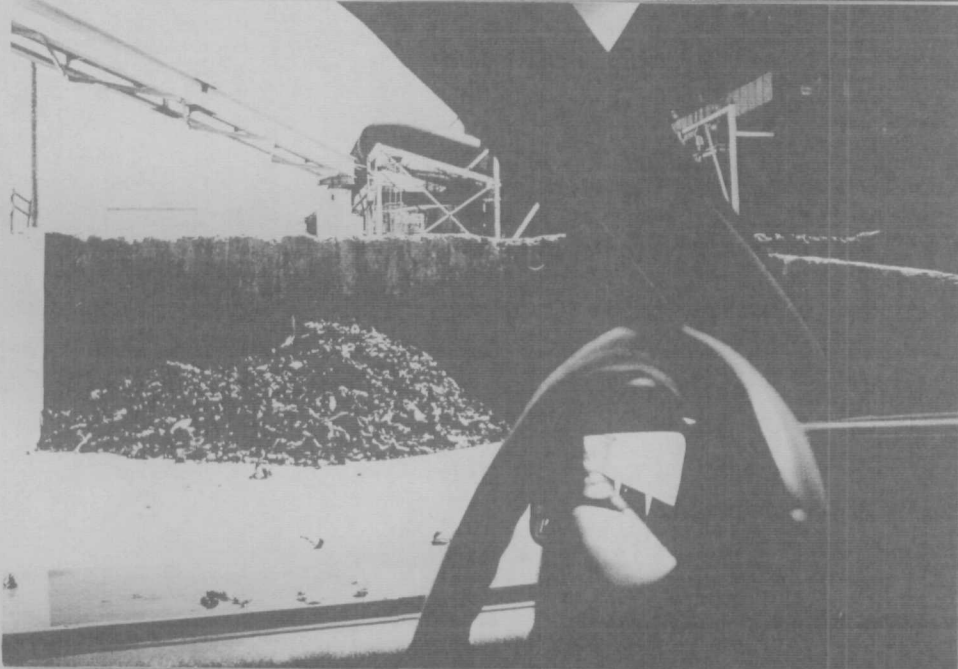
PROJECT/CASE NO: ASARCO E. Helena CAMU
 SUBJECT: Shredded tires
 LOCATION: Highline Bins
 CITY: E. Helena COUNTY: Lewis & Clark
 DATE: 07/16/01 TIME: AM
 WEATHER: (SUN)(HAZE)(CLOUDY)(RAIN)(SNOW)
 PHOTOGRAPHER (initials) Adel Johnson
 WITNESS: Susan Zazzali, EPA
 CAMERA: Vivitar Big View, BV35DB
 FILM TYPE: color ISO: 200
 NEGATIVE LOCATION: Attached to CEI report
 PROCESSED BY: Montana 1 Hour Photo
 PHOTO# 8

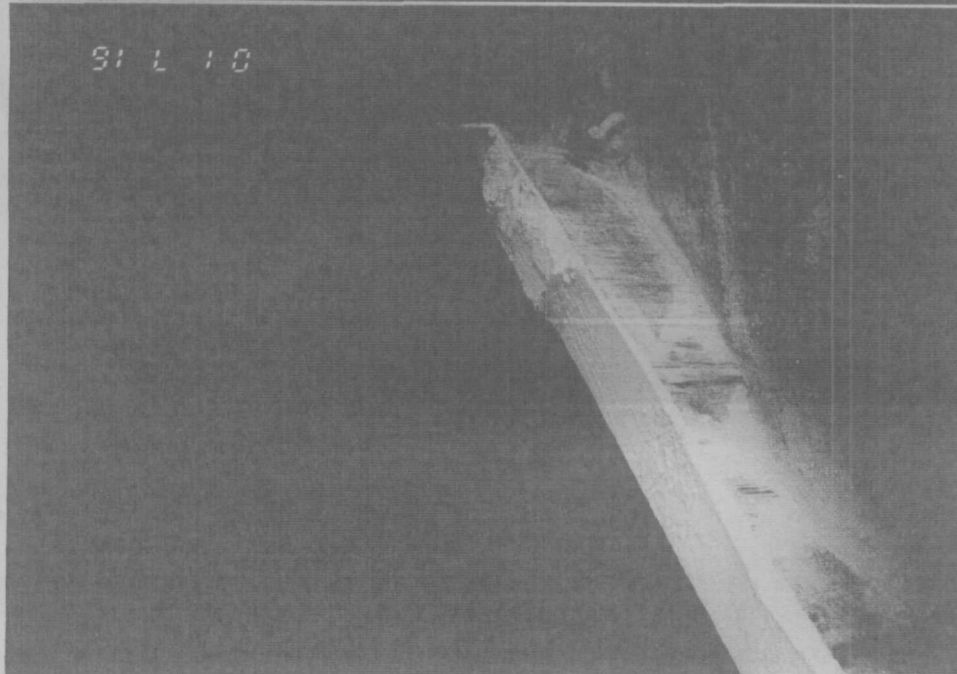
PROJECT/CASE NO: ASARCO E. Helena CAMU
 SUBJECT: E Helena sweeping material
 LOCATION: Ore Storage Building
 CITY: E. Helena COUNTY: Lewis & Clark
 DATE: 07/16/01 TIME: AM
 WEATHER: (SUN)(HAZE)(CLOUDY)(RAIN)(SNOW)
 PHOTOGRAPHER (initials) Adel Johnson
 WITNESS: Susan Zazzali, EPA
 CAMERA: Vivitar Big View, BV35DB
 FILM TYPE: color ISO: 200
 NEGATIVE LOCATION: Attached to CEI report
 PROCESSED BY: Montana 1 Hour Photo
 PHOTO# 9
